XVR Problem Modem 4G Datasheet incongruous

DH-XVR5108H-I3-8P

V4.001.0000004.1.R

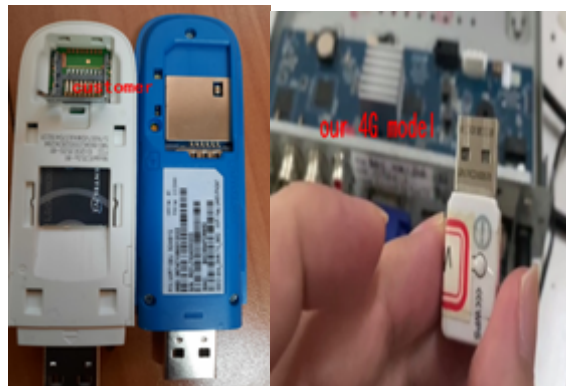
1. Make sure the device model belongs to NVR5X-I3 series, this model supports EW-7811UTC (white module)
2. Collect customer's 4G module and find that it is not supported by us

First of all, this model of equipment supports 4G functional modules. The customer feedback cannot be used because the 4G module used by the customer is not supported by this equipment, and needs to be replaced with EW-7811UTC (white module). If customers need existing 4G modules, they need to provide customized requirements
