## How to solve PTZ longevity warning issue

DH-SD5A232XA-HNR

V2.800.0000009.3.R.P9.3217.UN.NR Built date: 2020-03-31

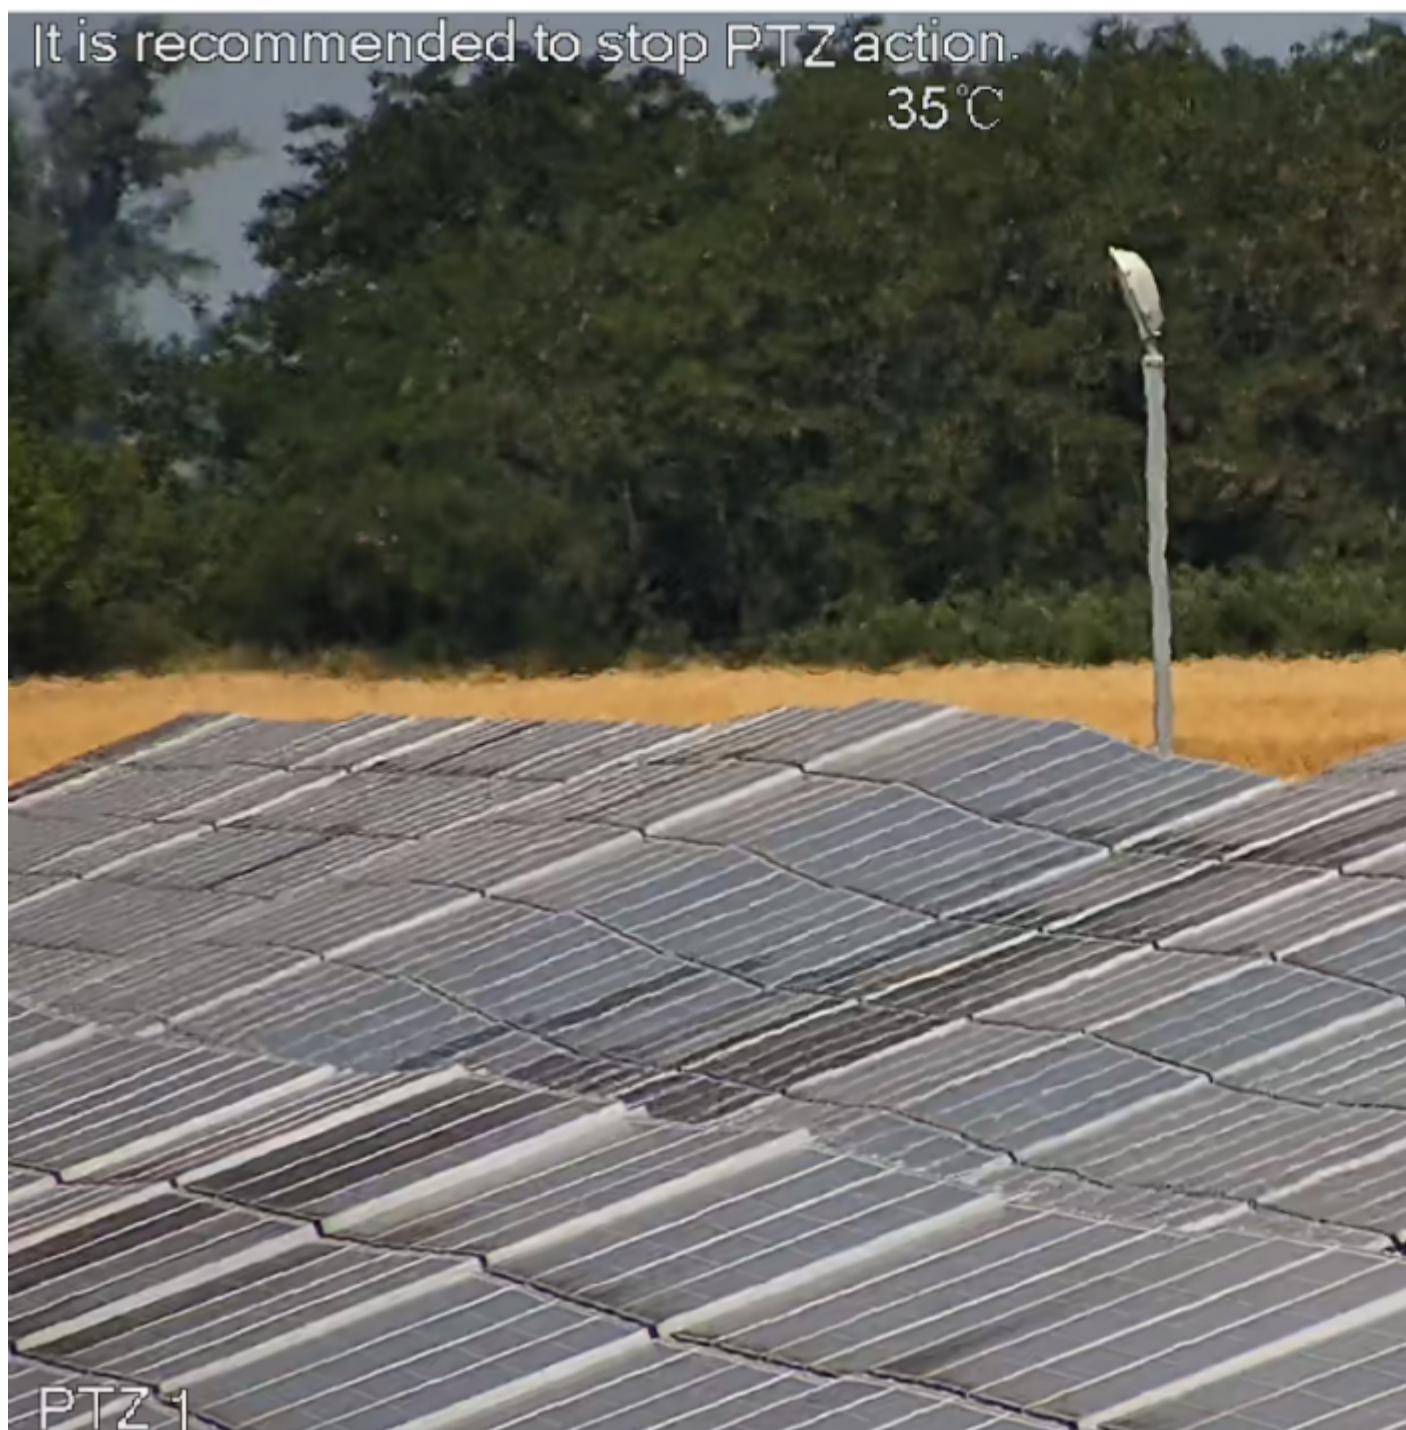
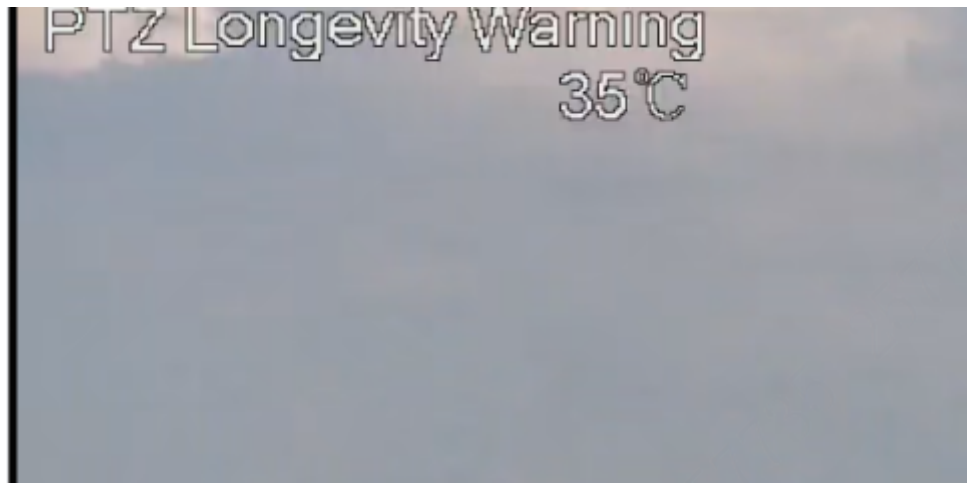
PTZ camera DH-SD5A232XA-HNR, installed in November 2021, Has PTZ Longevity Warning. Reboot camera and factory reset all can't fix the issue. The screen displays the following: It is recommended to stop PTZ action.

PTZ longevity is independent of actual installation time. This info appears because too many PTZ functions(Pattern,tour,etc) are used. Turning this feature off can solve the problem.Need to turn off the PTZ life warning.The path is as following:Setting->Camera->Video->Overlay->OSD info->PTZ life warning->Disable

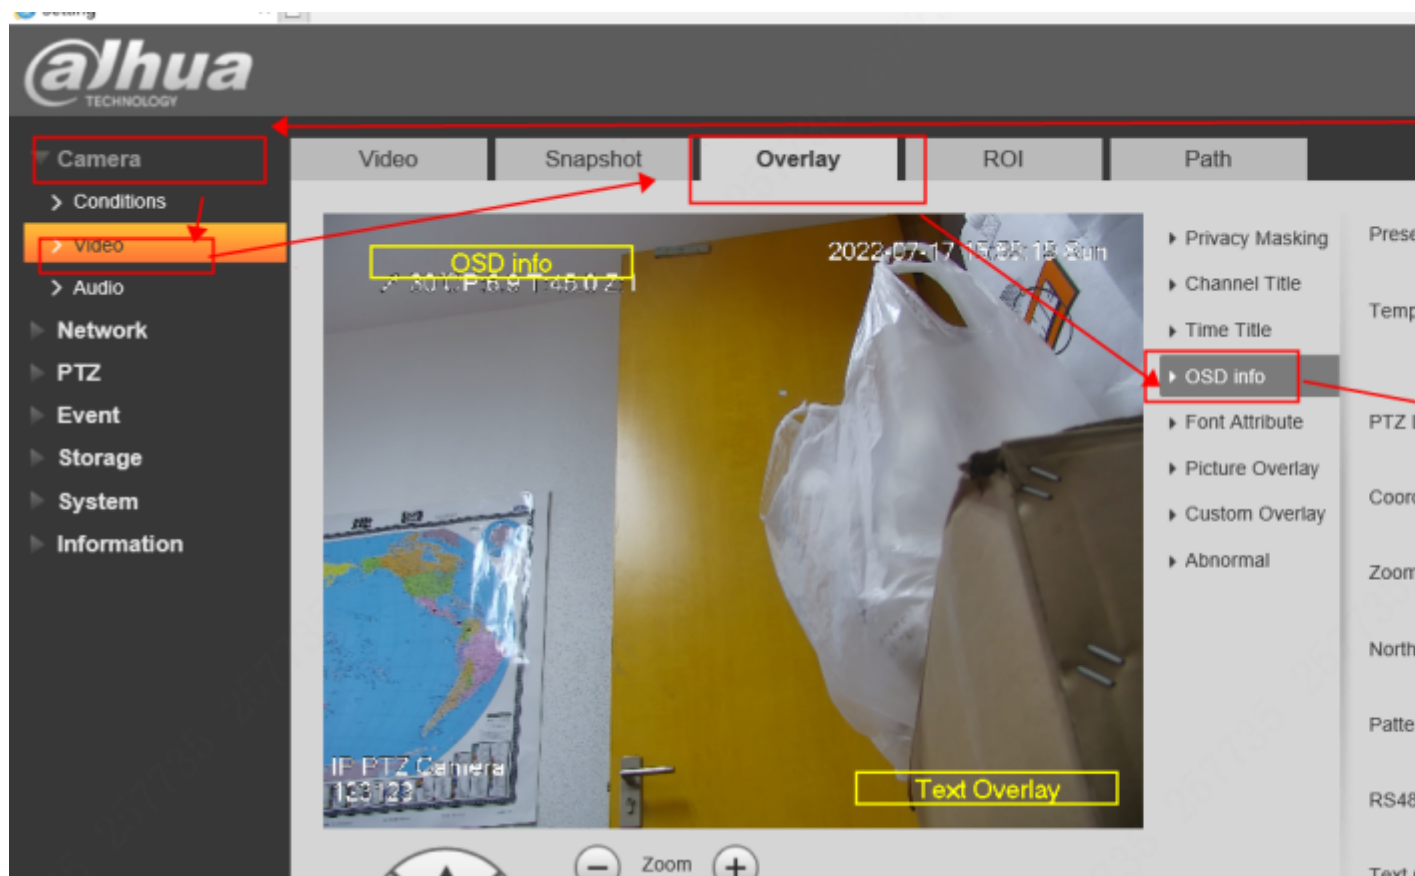
1. Update the camera to latest fw to see whether the issue can be solved.
2. Enter the following path to close the longevity warning:
