Image Turns Too Bright in Day

1. Product Model and Firmware Version

DH-IPC-HFW5241TP-SE-0360B

DH_IPC-HX5XXXolt_MultiLang_PN_Stream3_V2.840.000000.13.R.220110

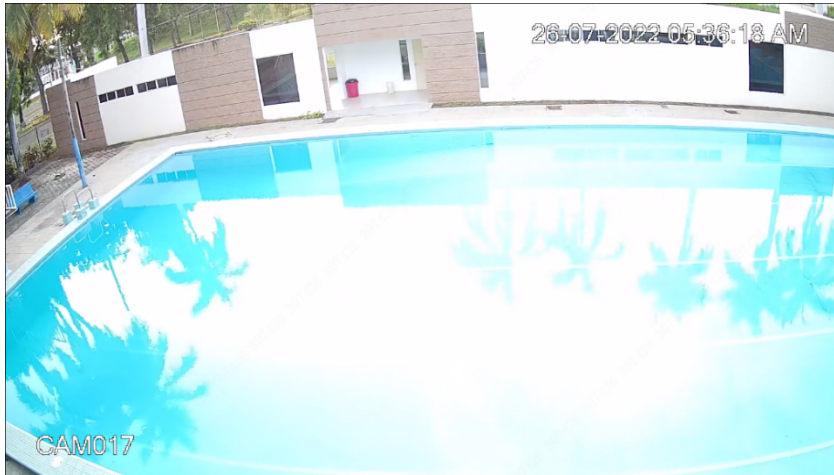
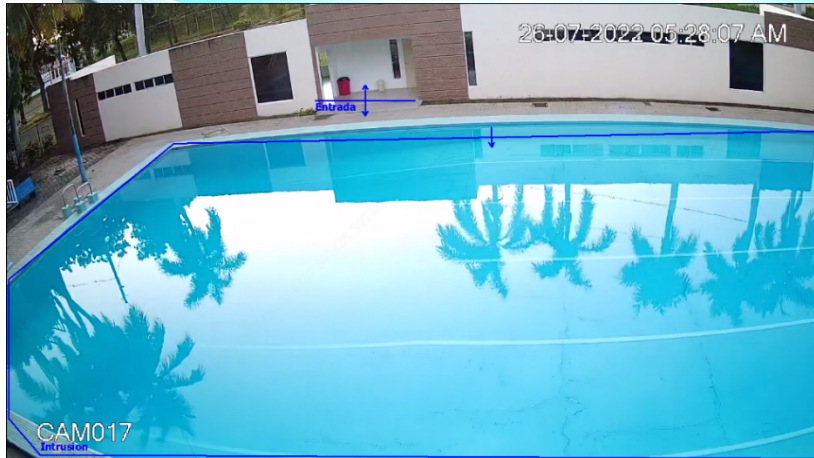
After a time connected, the image start turning brighter. A restart will fix the issue. But next day the problem will recur.

Since this device does not support the adjustment of the aperture, the problem should not be caused by the aperture. between the remaining possible factors, the settings for the gain and picture options have not been changed, so the problem is most likely related to the shutter.

Check the shutter setting of the device and found that IPC was set a fixed shutter speed. This speed is reasonable at night, but the value is obviously too slow for

daytime, and the gradual increase in sunlight brightness at sunrise combined to cause the problem.
